# Guam Waterworks Authority (VP0989)

## CWA Collection System

Tumon, Guam

NEIC Field Investigation Photographs  
April 24 through May 4

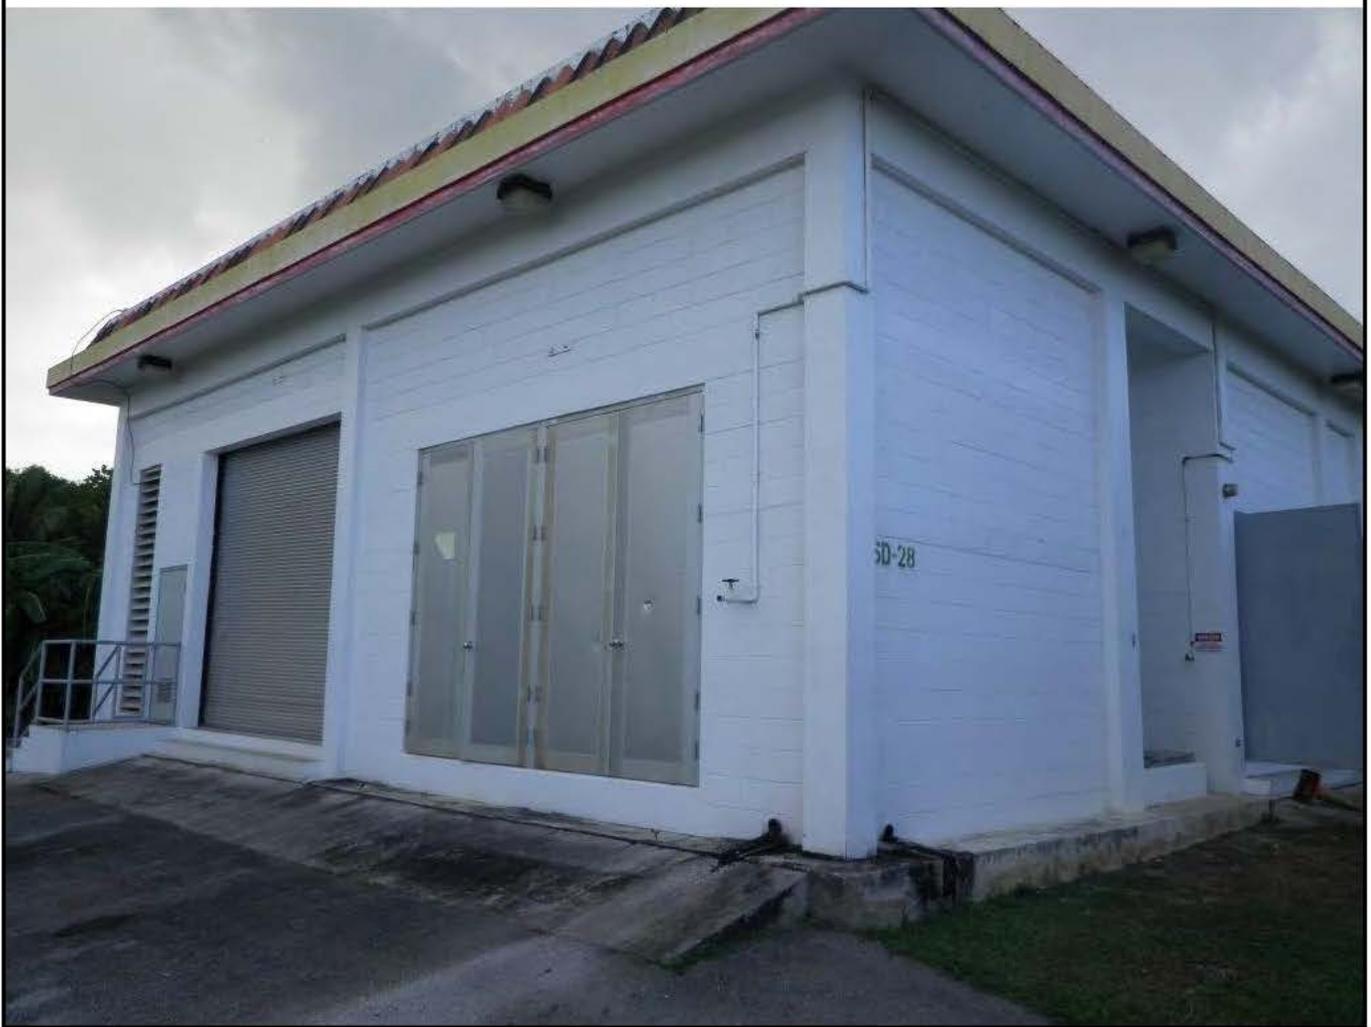
File Name: RIMG0002.JPG

Title	Guam Waterworks Authority (VP0989)
Subject	CWA Collection System
[REDACTED]	[REDACTED]
[REDACTED]	[REDACTED]
Date Time Stamp	4/25/2012 10:26:47 AM
Photographer	D. Vanlerberghe
Description	Chaligan pump station building

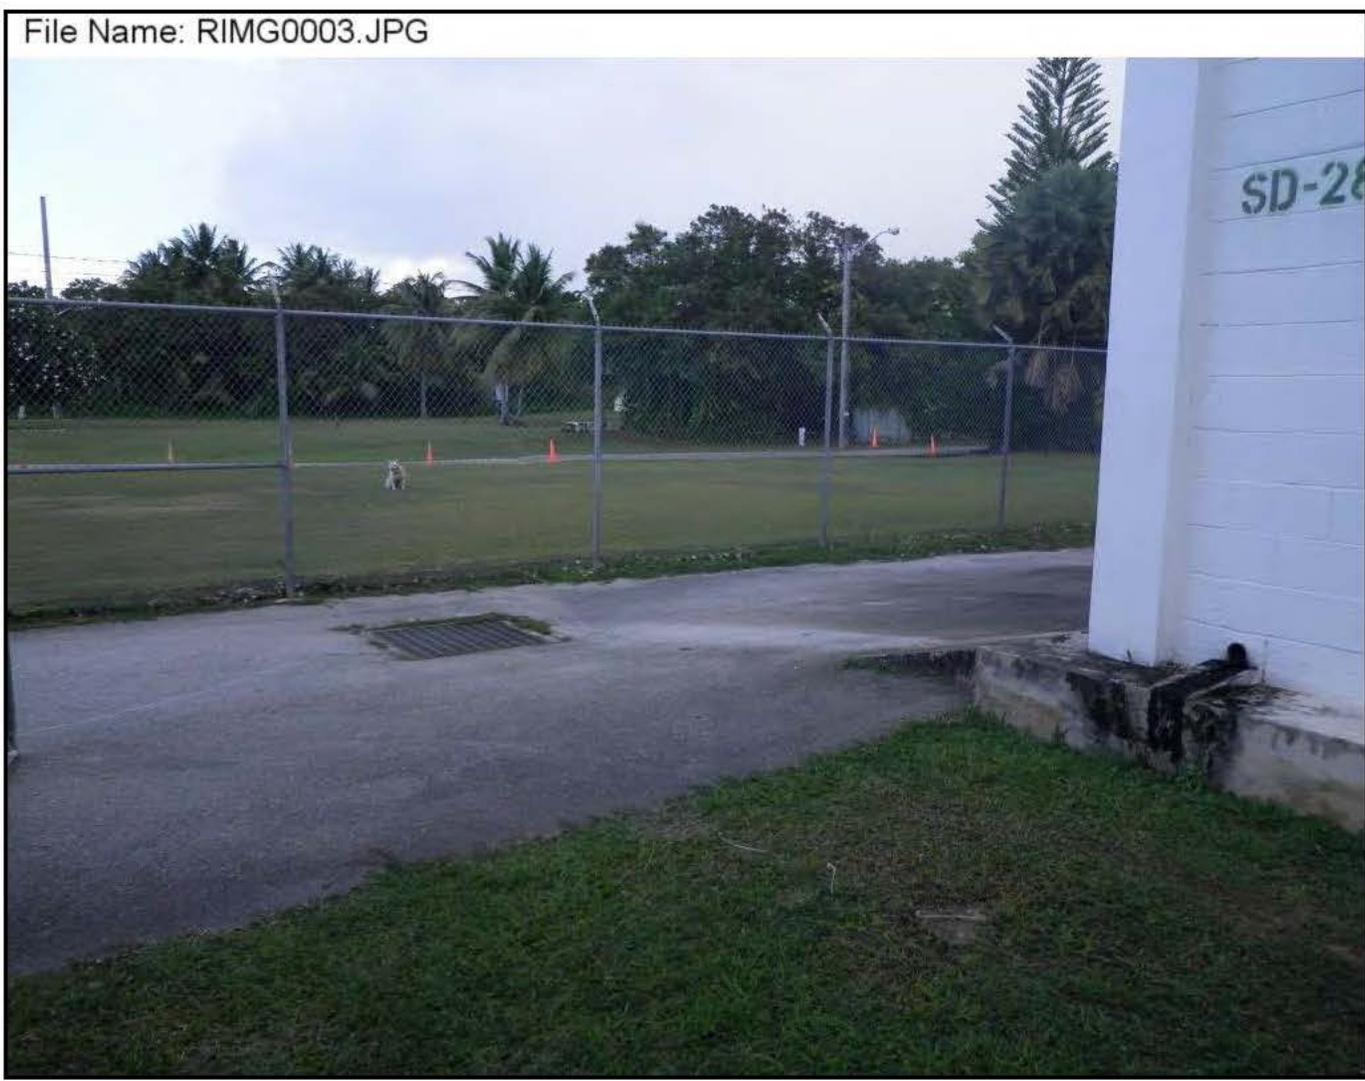
Attributes	
Title	Guam Waterworks Authority (VP0989)
Subject	CWA Collection System
Date Time Stamp	4/25/2012 10:30:20 AM
Photographer	D. Vanlerberghe
Description	Chaligan pump station, showing storm drain inlet on northwest side of building, which may drain to pump station wet well

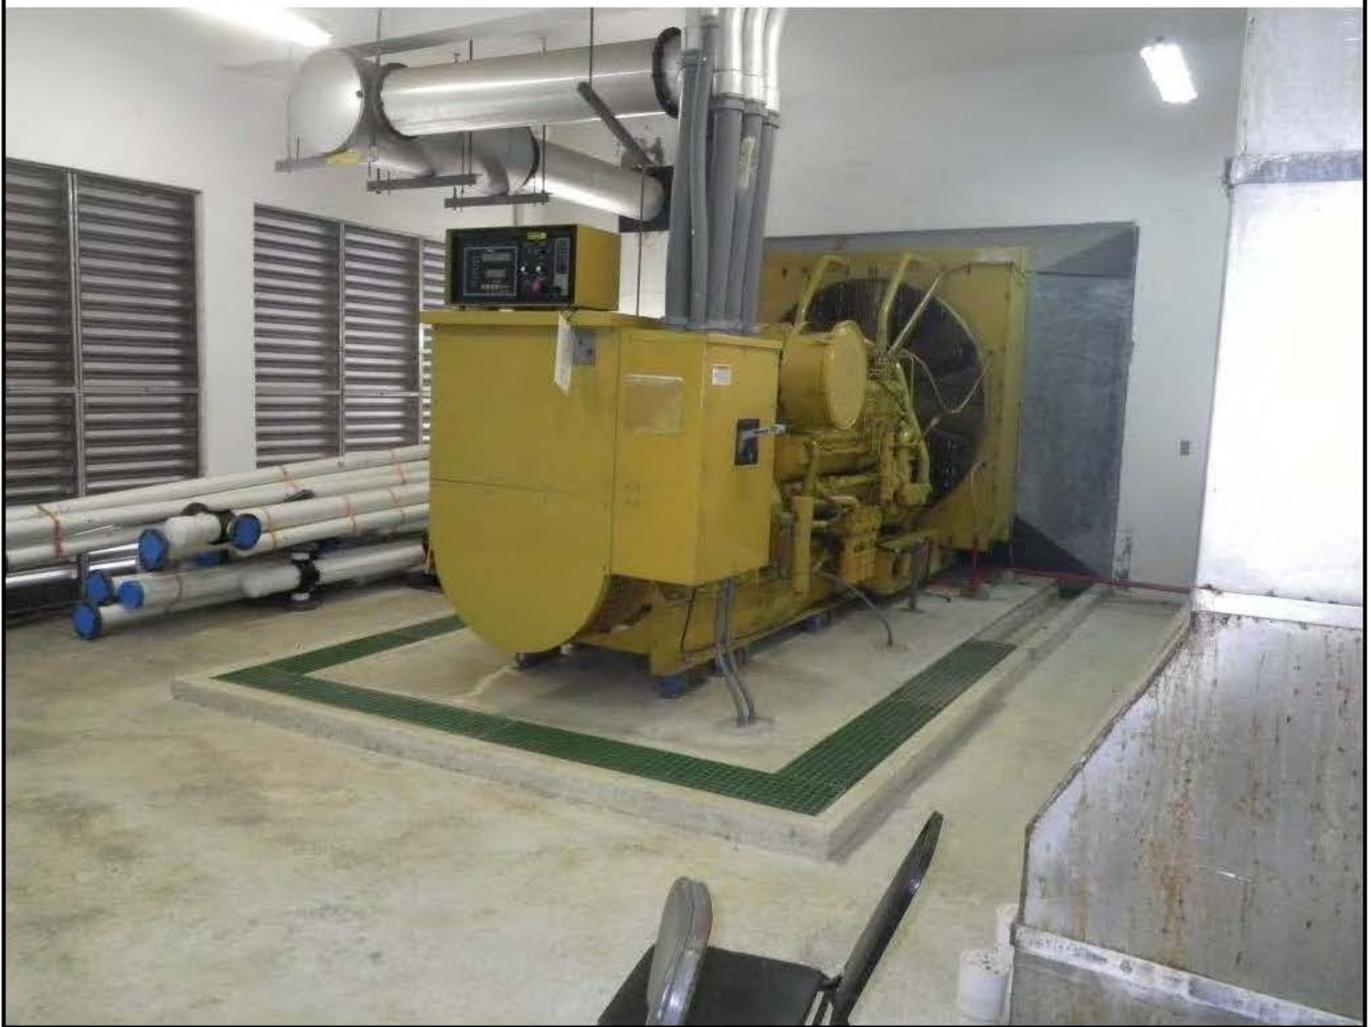
File Name: RIMG0006.JPG

Title	Guam Waterworks Authority (VP0989)
Subject	CWA Collection System
Date Time Stamp	4/25/2012 11:42:00 AM
Photographer	D. Vanlerberghe
Description	Standby generator, Ga'an pump station

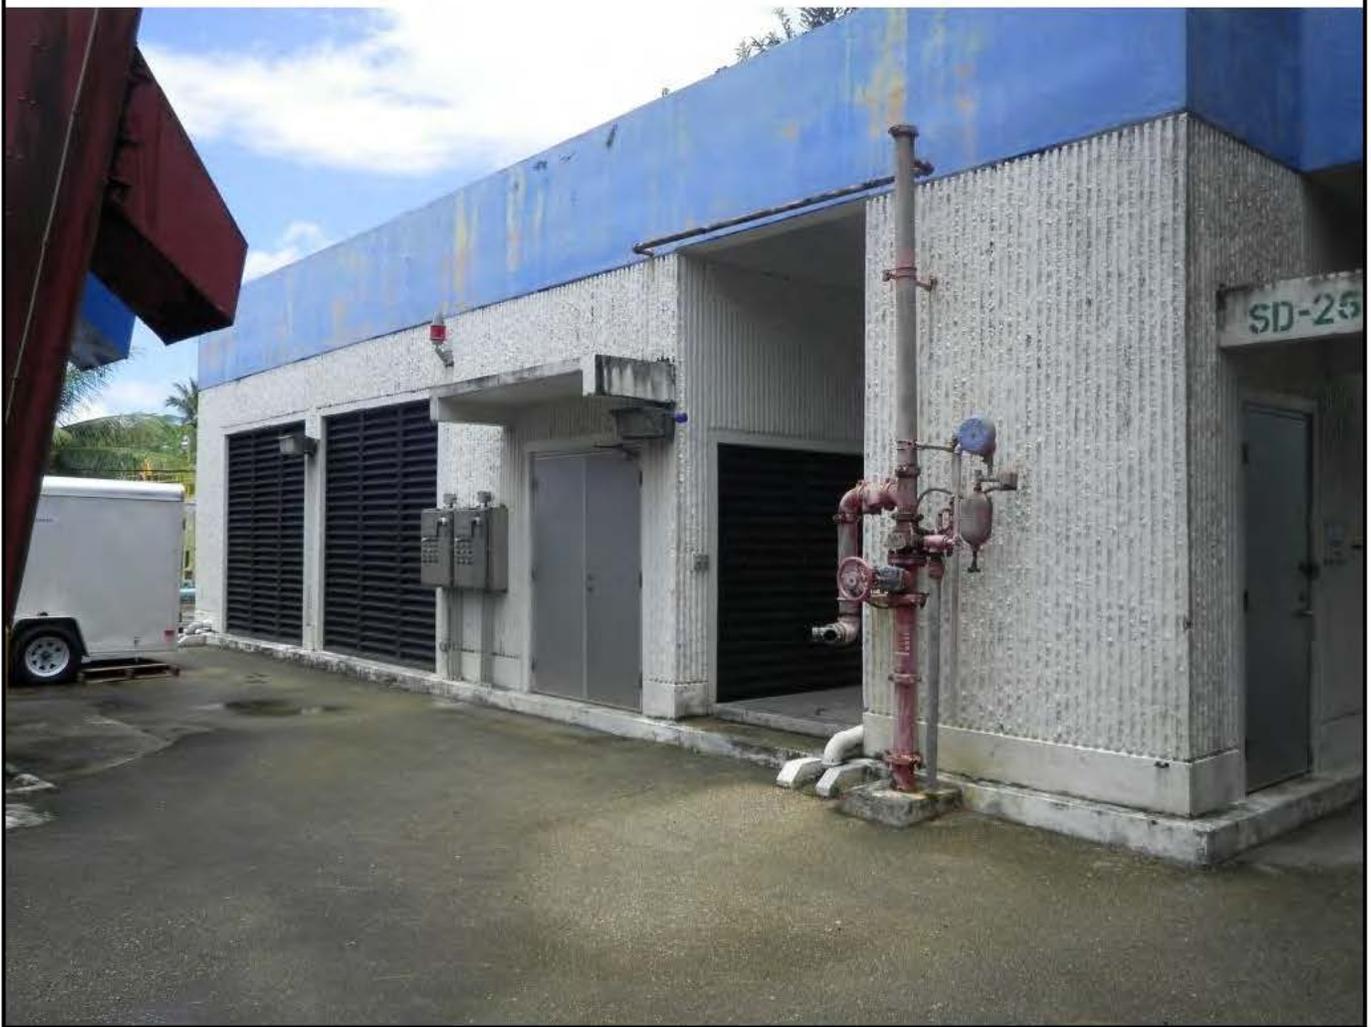
File Name: RIMG0008.JPG

Title	Guam Waterworks Authority (VP0989)
Subject	CWA Collection System
Date Time Stamp	4/25/2012 11:44:47 AM
Photographer	D. Vanlerberghe
Description	Ga'an pump station building

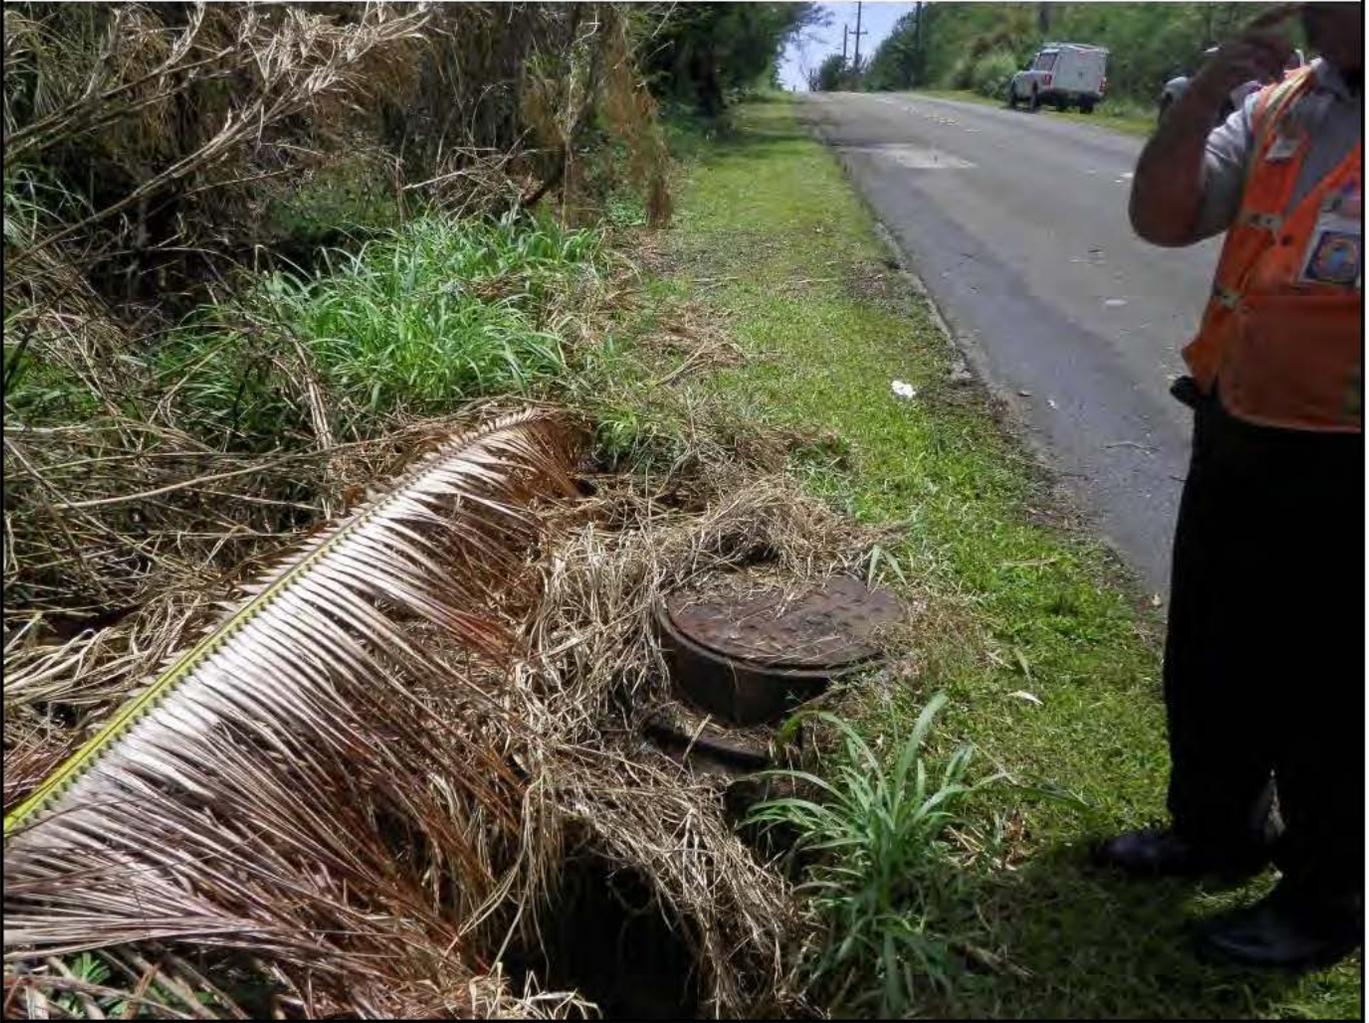
File Name: RIMG0009.JPG

Title	Guam Waterworks Authority (VP0989)
Subject	CWA Collection System
Date Time Stamp	4/25/2012 1:36:03 PM
Photographer	D. Vanlerberghe
Description	Manhole directly across the road from Merizo pump station No. 12, on east side of road, near roadside storm ditch. Manhole was exposed and damaged, with potential for direct inflow into manhole below the manhole collar.

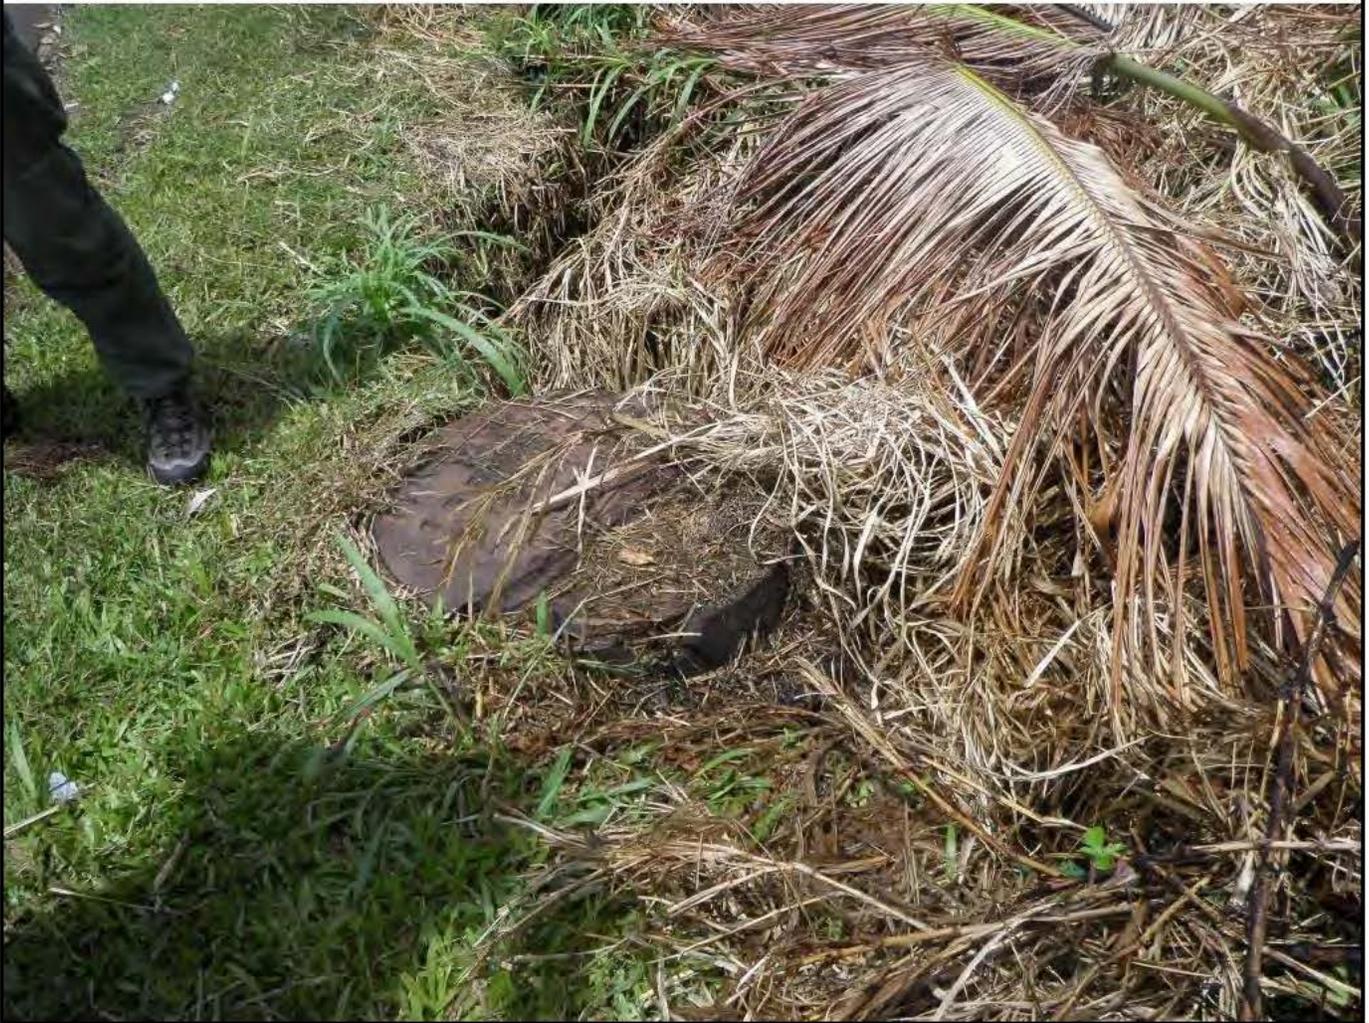
File Name: RIMG0010.JPG

Attributes	
Title	Guam Waterworks Authority (VP0989)
Subject	CWA Collection System
Date Time Stamp	4/25/2012 1:38:23 PM
Photographer	D. Vanlerberghe
Description	Manhole directly across the road from Merizo pump station No. 12, on east side of road, near roadside storm ditch. Manhole was exposed and damaged, with potential for direct inflow into manhole below the manhole collar.

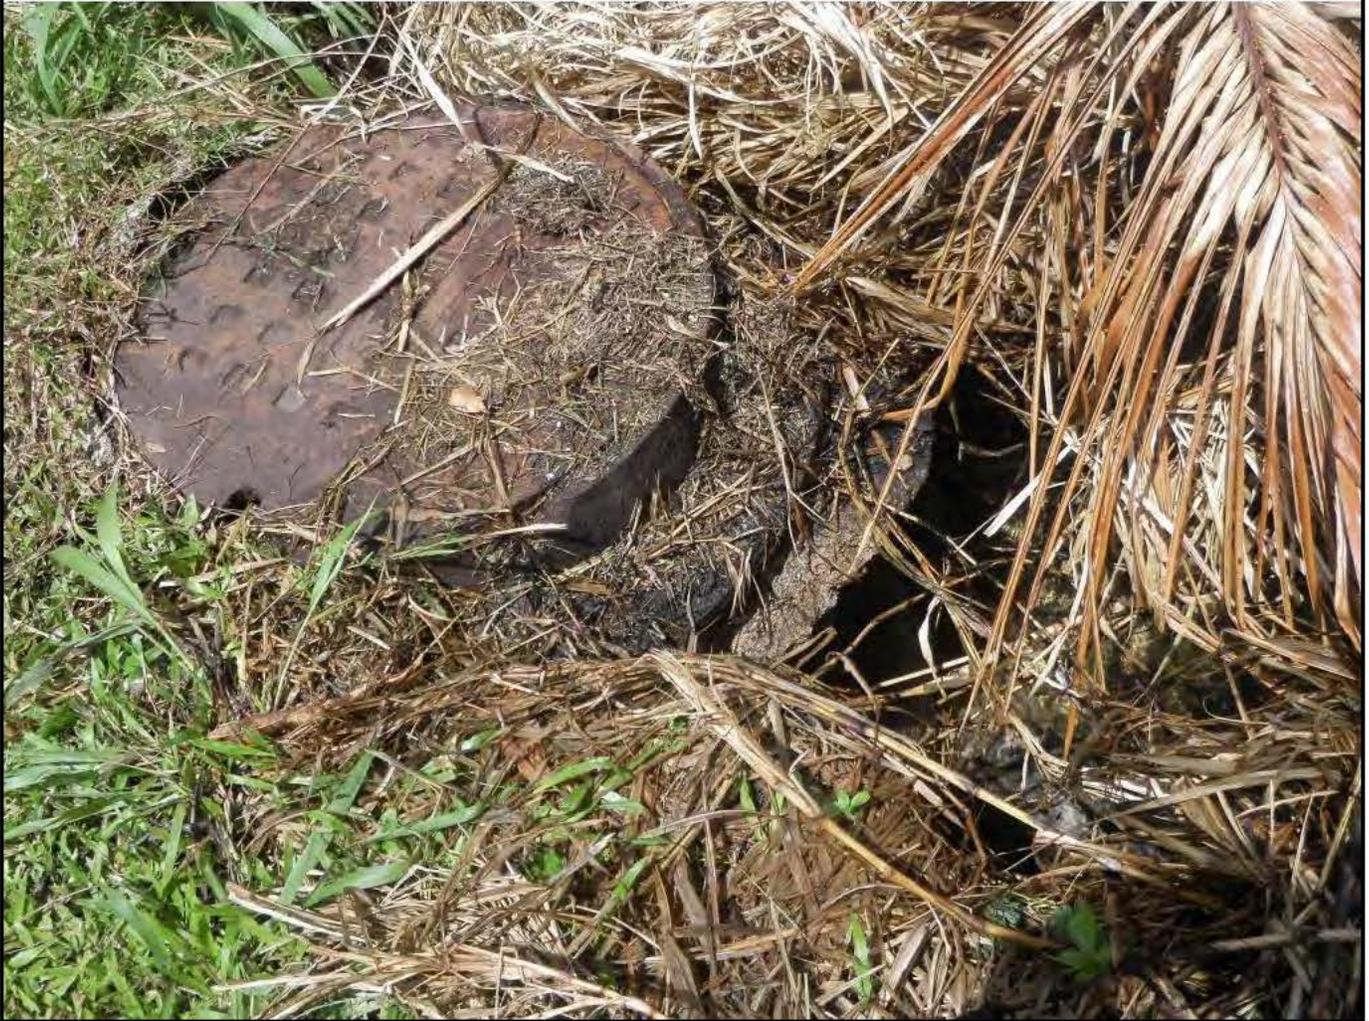
File Name: RIMG0011.JPG

<b>Title</b>	Guam Waterworks Authority (VP0989)
<b>Subject</b>	CWA Collection System
<b>Date Time Stamp</b>	4/25/2012 1:39:48 PM
<b>Photographer</b>	D. Vanlerberghe
<b>Description</b>	Manhole directly across the road from Merizo pump station No. 12, on east side of road, near roadside storm ditch. Manhole was exposed and damaged, with potential for direct inflow into manhole below the manhole collar.

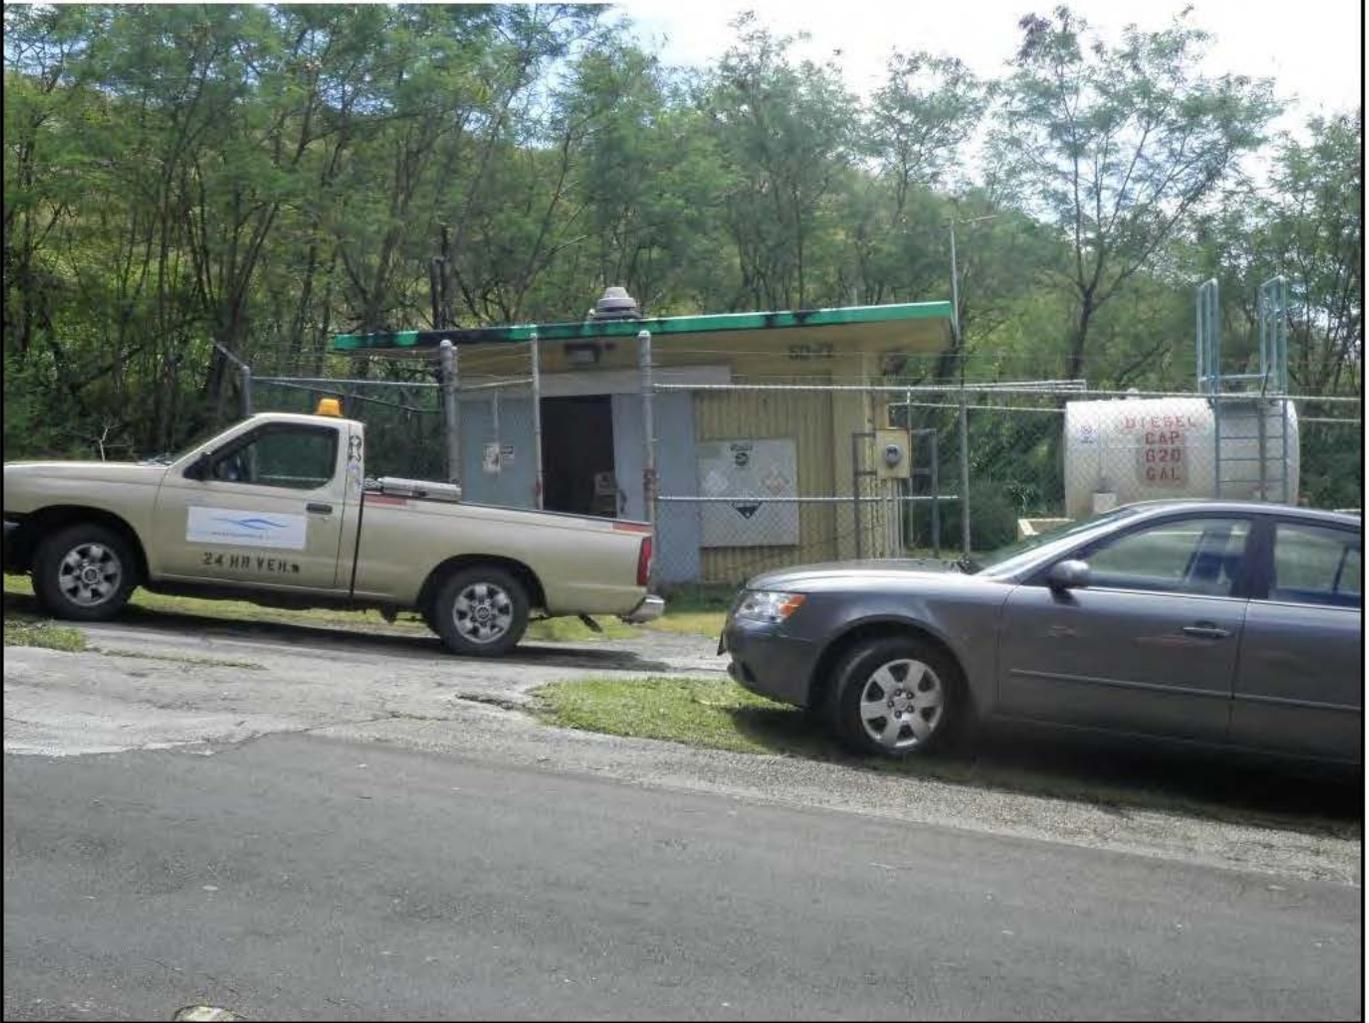
File Name: RIMG0012.JPG

Title	Guam Waterworks Authority (VP0989)
Subject	CWA Collection System
Date Time Stamp	4/25/2012 1:41:41 PM
Photographer	D. Vanlerberghe
Description	Merizo pump station No. 12

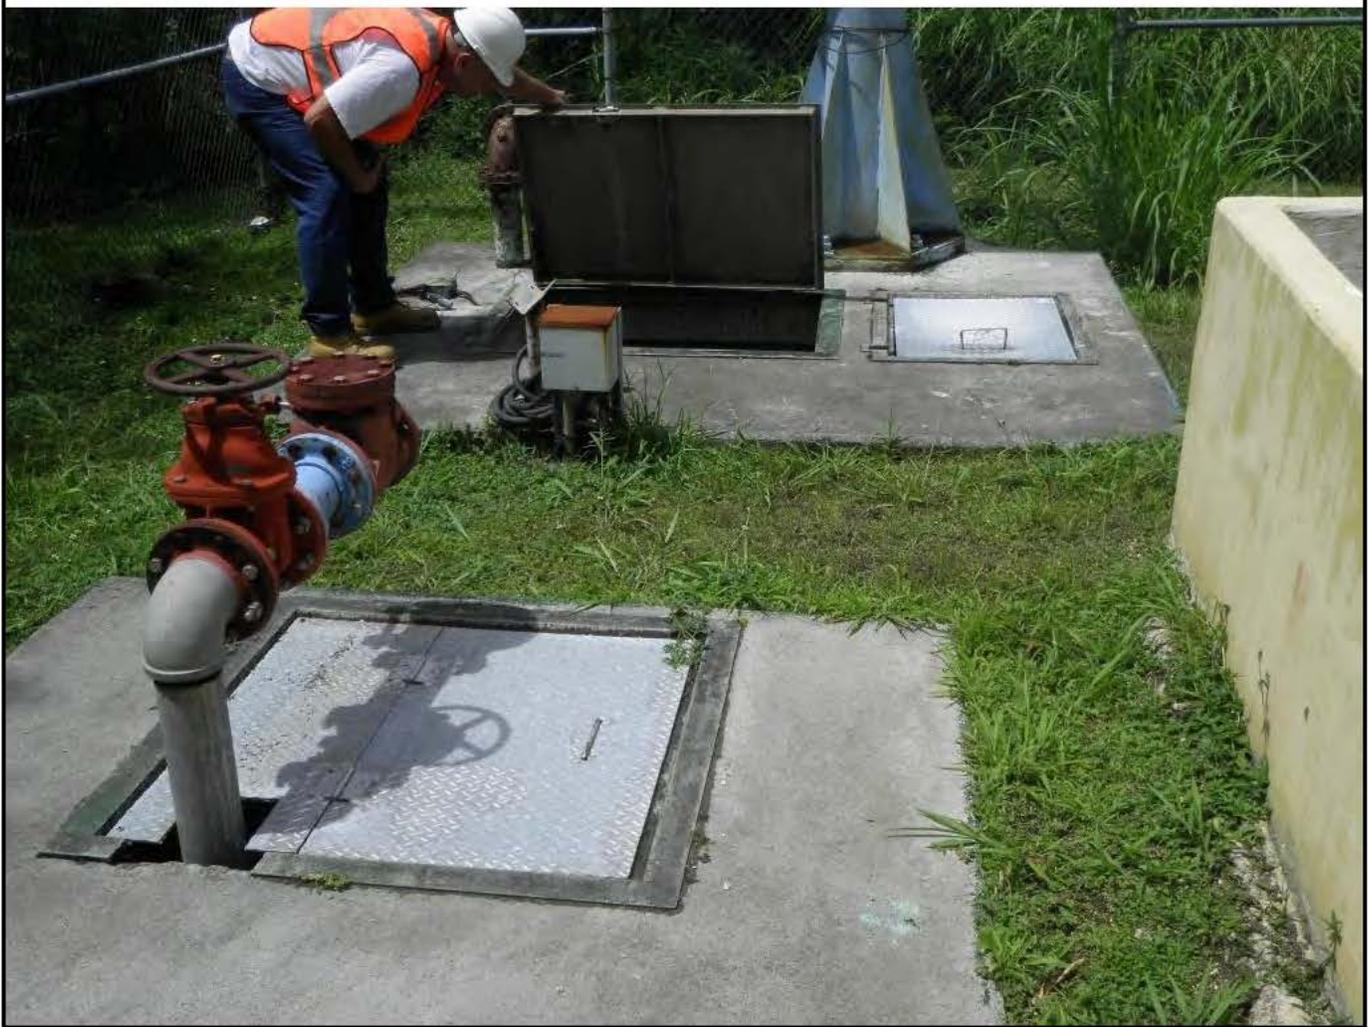
File Name: RIMG0014.JPG

Title	Guam Waterworks Authority (VP0989)
Subject	CWA Collection System
Date Time Stamp	4/25/2012 1:48:51 PM
Photographer	D. Vanlerberghe
Description	Merizo pump station No. 12 pump housing and wet well

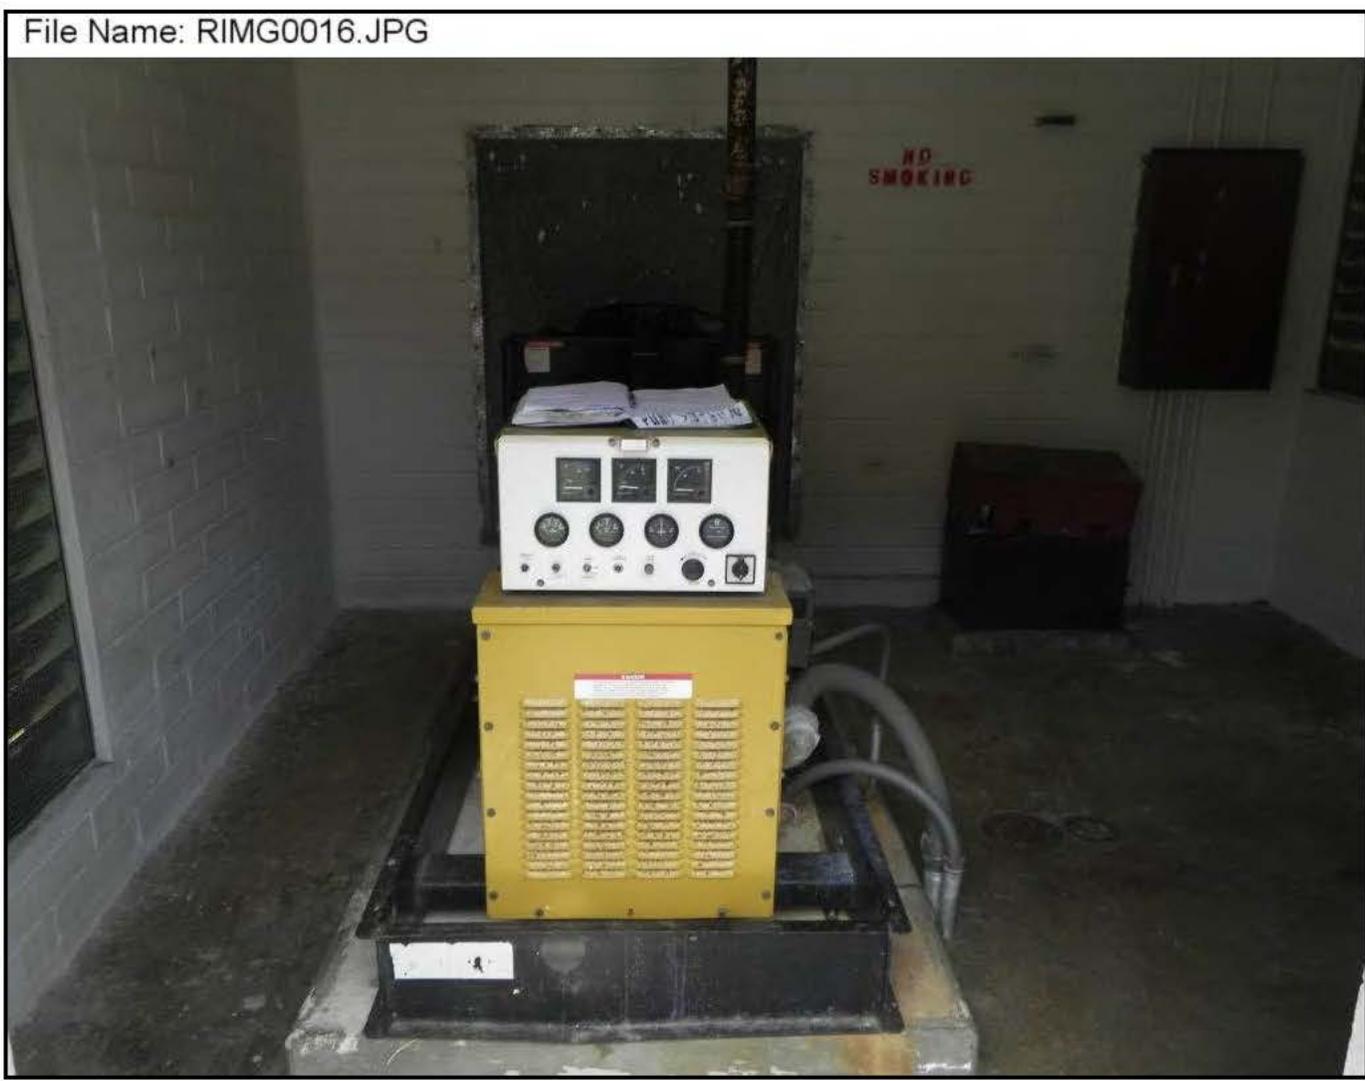
Attributes	
Title	Guam Waterworks Authority (VP0989)
Subject	CWA Collection System
Date Time Stamp	4/25/2012 2:03:52 PM
Photographer	D. Vanlerberghe
Description	Merizo pump station No. 14 standby generator

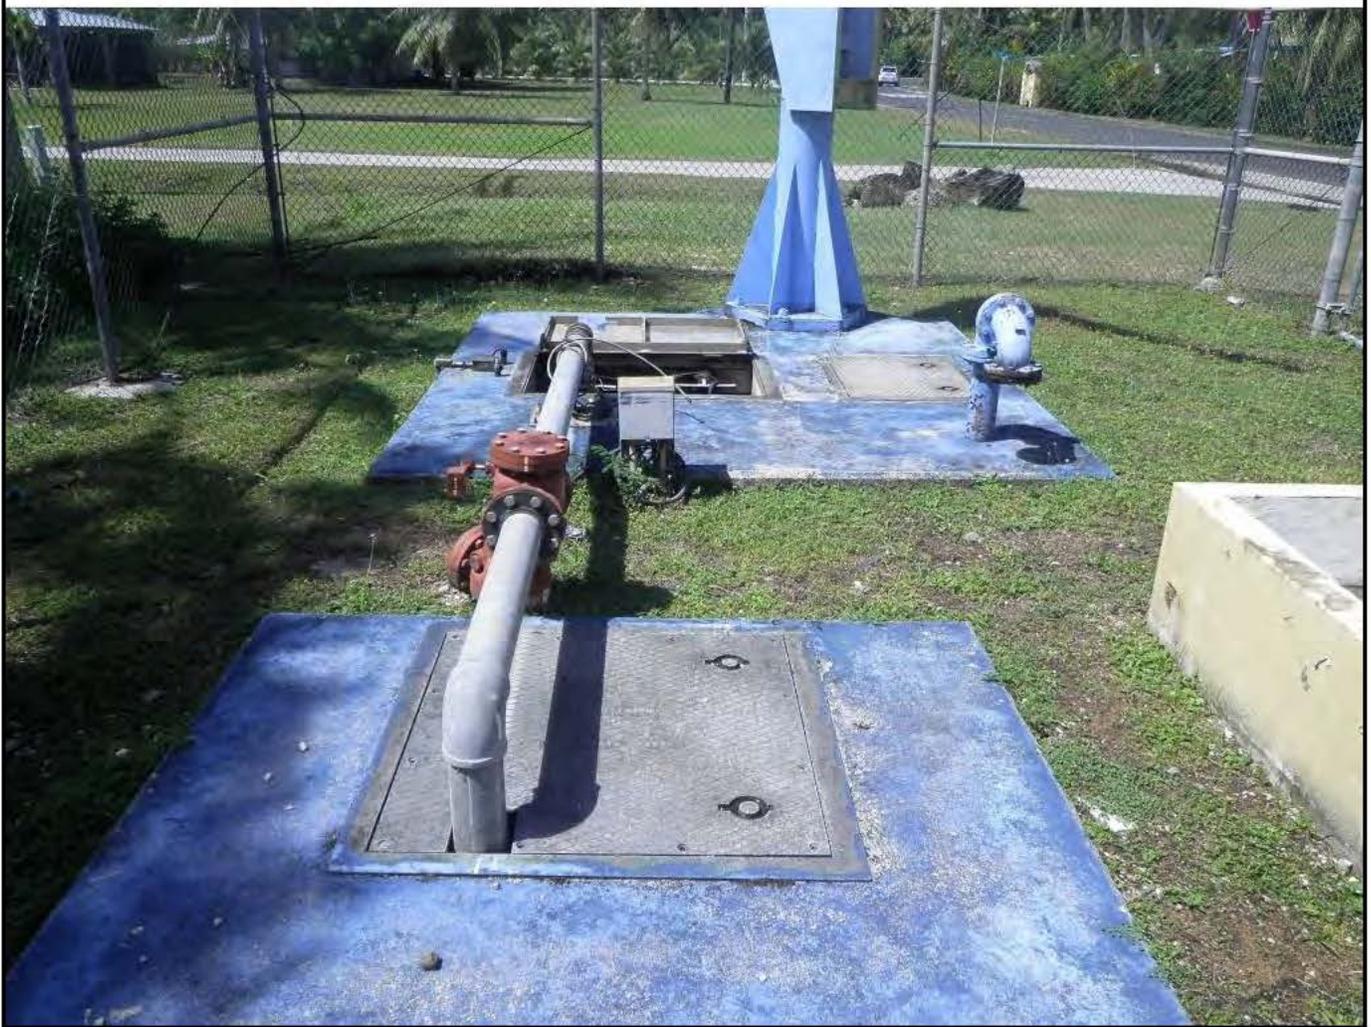
File Name: RIMG0020.JPG

Title	Guam Waterworks Authority (VP0989)
Subject	CWA Collection System
Date Time Stamp	4/25/2012 2:26:48 PM
Photographer	D. Vanlerberghe
Description	Merizo pump station No. 17 pump housing and wet well

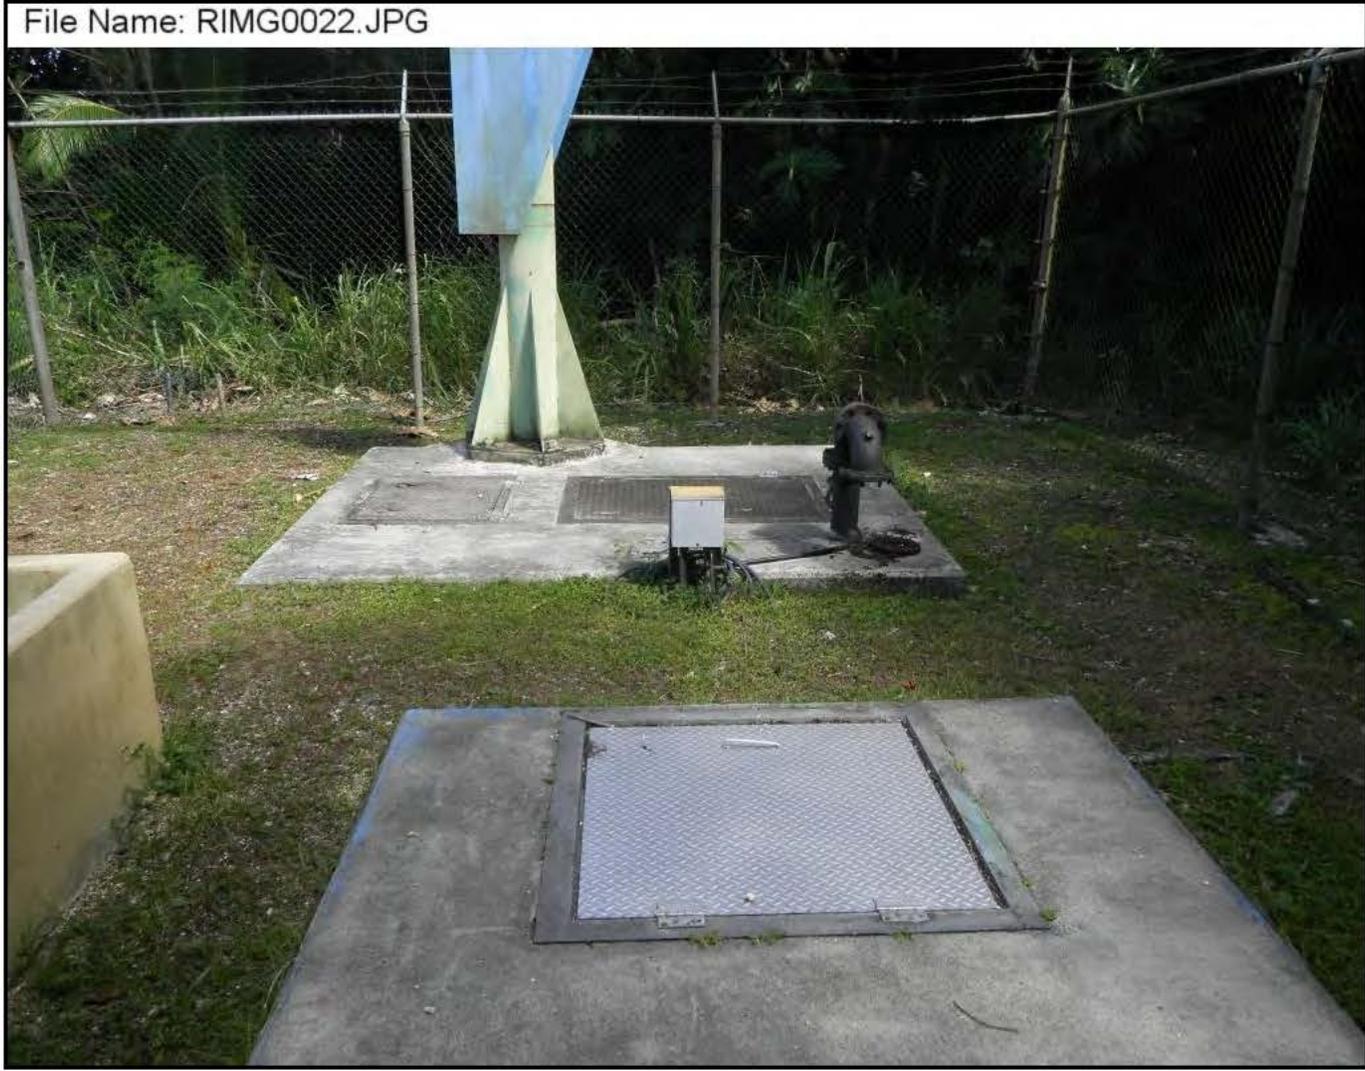
Attributes	
Title	Guam Waterworks Authority (VP0989)
Subject	CWA Collection System
Date Time Stamp	4/25/2012 2:45:52 PM
Photographer	D. Vanlerberghe
Description	Merizo pump station No. 18 pump housing and wet well

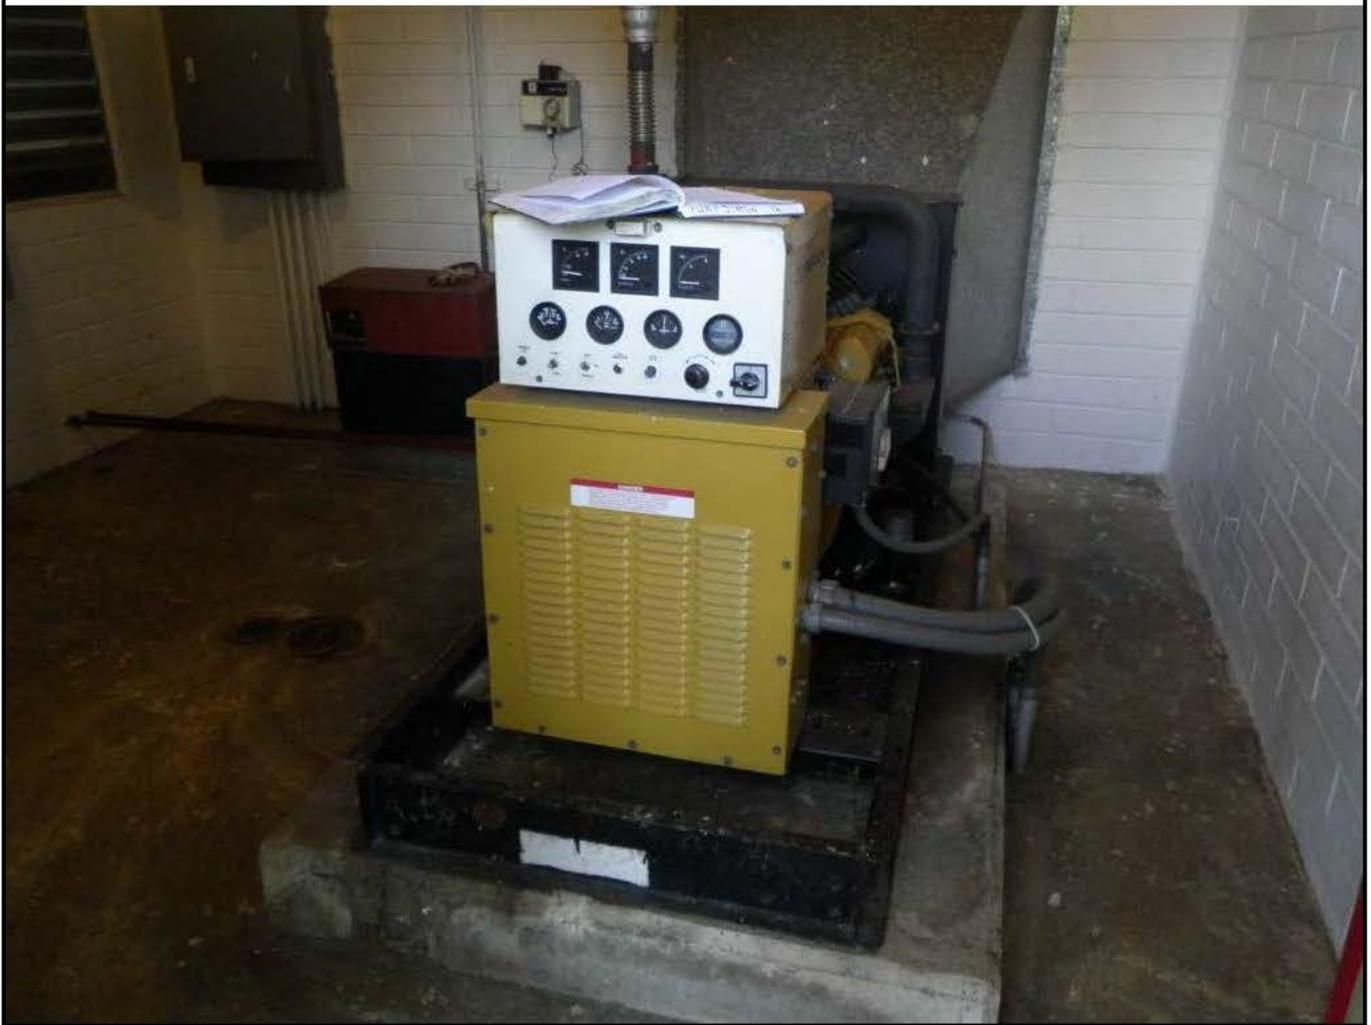
File Name: RIMG0023.JPG

Attributes	
Title	Guam Waterworks Authority (VP0989)
Subject	CWA Collection System
Date Time Stamp	4/25/2012 2:47:41 PM
Photographer	D. Vanlerberghe
Description	Merizo pump station No. 18 standby generator

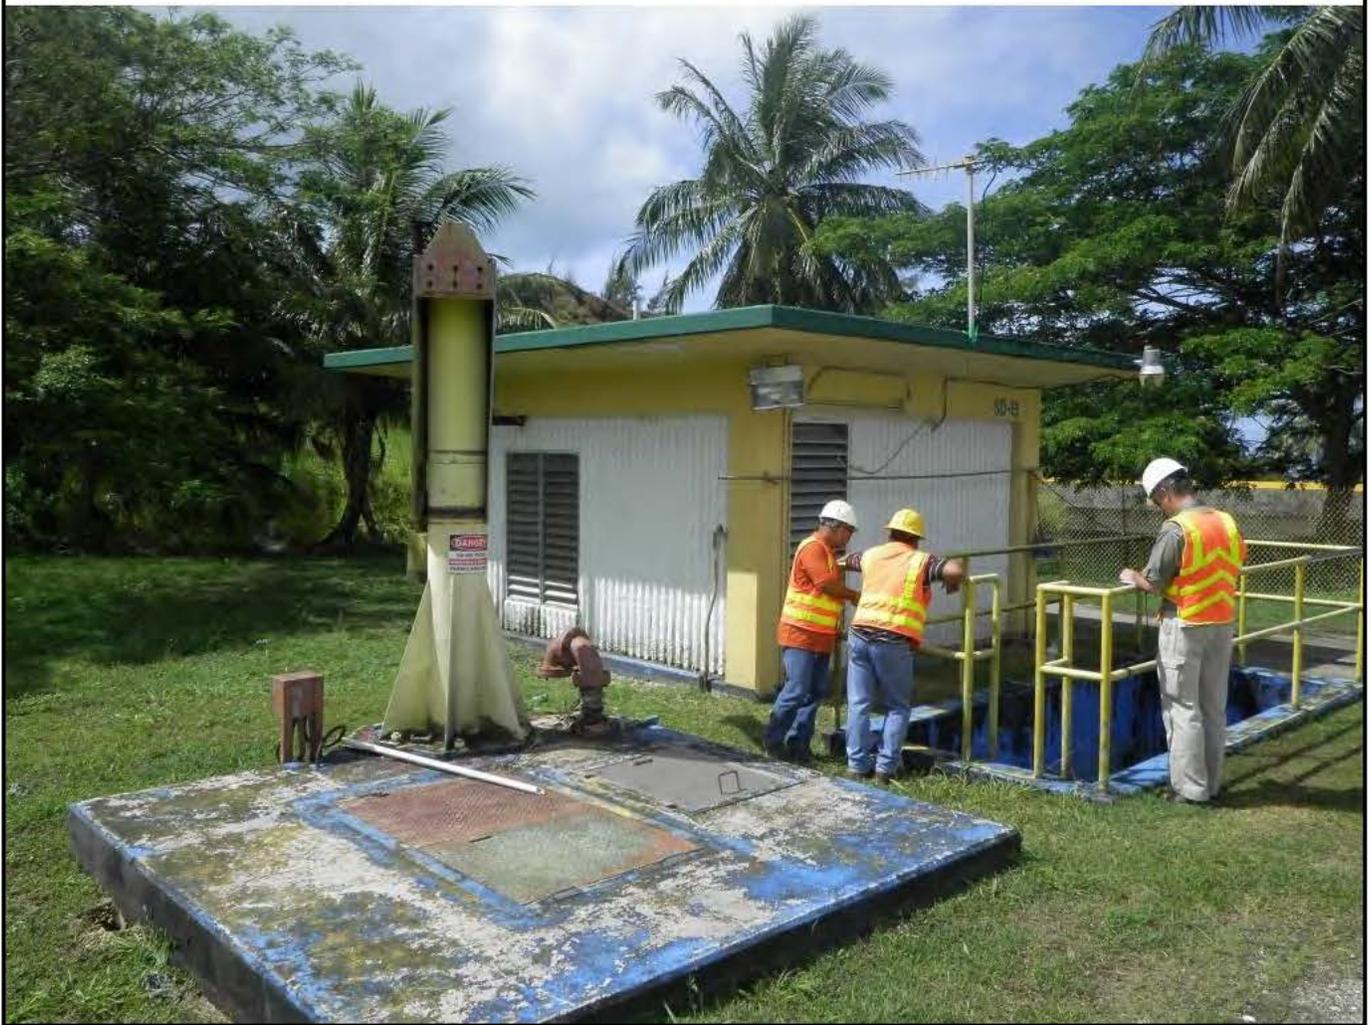
File Name: RIMG0024.JPG

Title	Guam Waterworks Authority (VP0989)
Subject	CWA Collection System
Date Time Stamp	4/26/2012 9:51:58 AM
Photographer	D. Vanlerberghe
Description	Merizo pump station No. 13, influent to Umatac WWTP

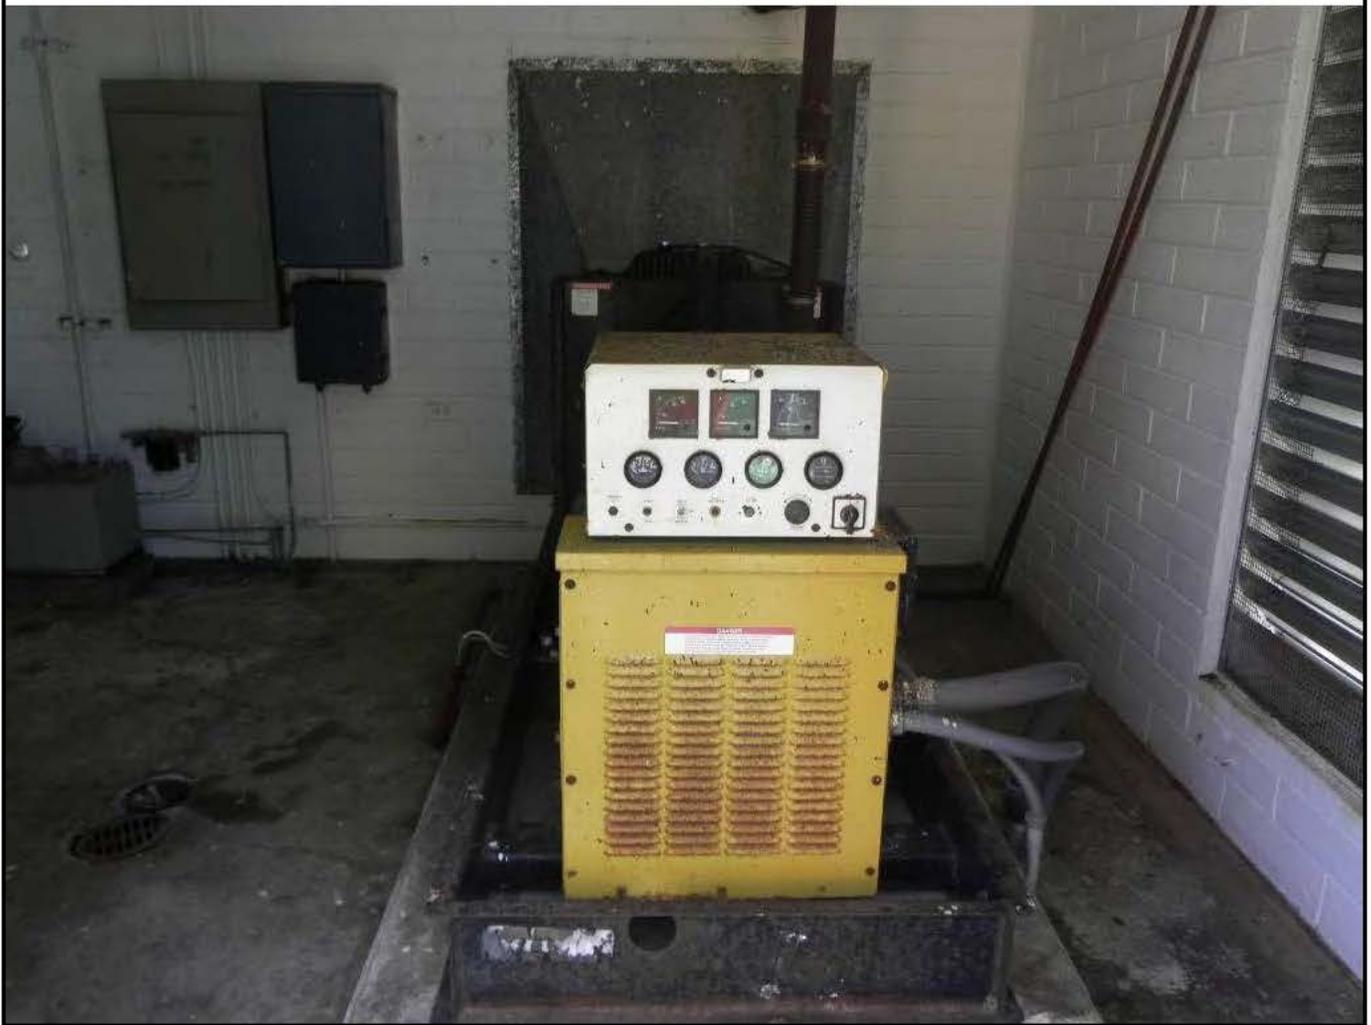
File Name: RIMG0025.JPG

Title	Guam Waterworks Authority (VP0989)
Subject	CWA Collection System
Date Time Stamp	4/26/2012 10:02:59 AM
Photographer	D. Vanlerberghe
Description	Merizo pump station No. 13 standby generator
